**Lightweight Shock Test Report**  
**on**  
**Power Supply PS1503-H-MB and Adapter Plate**  
**for**  
**Powerstar Inc.**  
**Gaithersburg, MD**

**16 May 2012**

The purpose of this test was to demonstrate that the Power Supply PS1503-H-MB and Adapter Plate (herein collectively referred to as the "Power Supply and Plate") complied with the requirements of MIL-S-901D for a Grade A, Class I, Type A, nine (9) blow lightweight shock test.

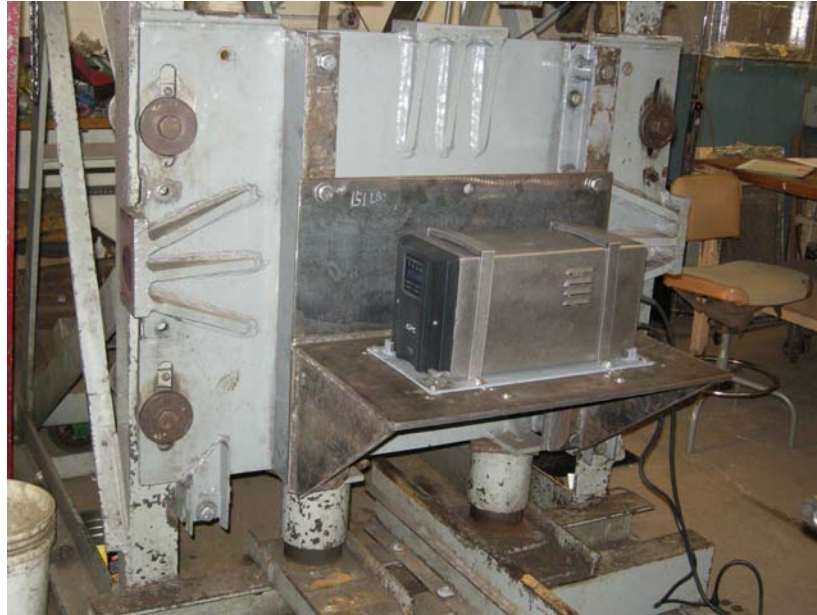
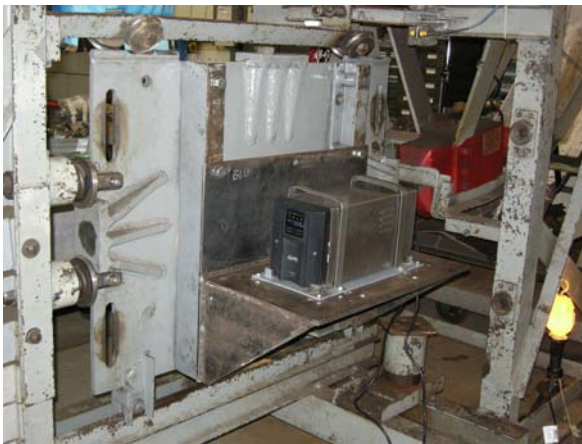
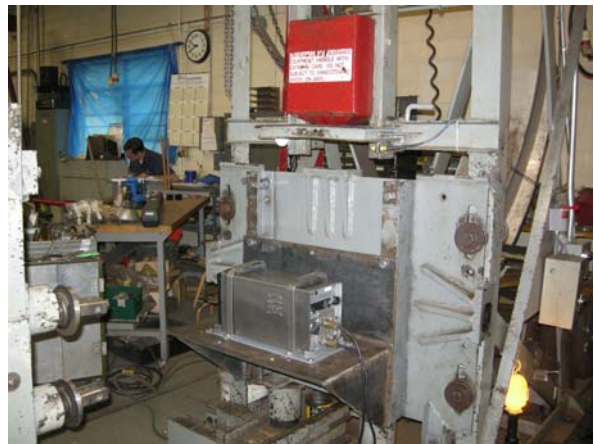
**Test Setups  
Figure 1**

The Adapter Plate was bolted to Fixture 4C, Platform 3 of MIL-S-901D using four (4) 5/16"-18 stainless steel bolts torqued to 11.5 ft-lbs. The Power Supply PS1503-H-MB was placed upon the Adapter Plate and secured by two (2) metal straps bolted to the Adapter Plate using one (1) 5/16"-18 stainless steel bolt torqued to 11.5 ft-lbs in each strap, for a total of four (4) 5/16"-18 stainless steel bolts. Fixture 4C of MIL-S-901D was secured to the lightweight shock machine, oriented in the first axis of test. Refer to Figure 1 for photographs of the test setups. The total weight on the lightweight shock machine was 320 pounds; refer to Table 1 for a breakdown of the test weights.

**Side-to-Side Axis**

**Front-to-Back Axis**

**Top Axis**

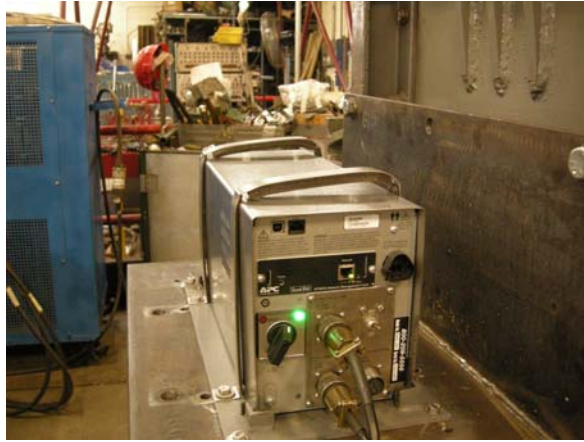
**Post-Blow #2, Bent Top Brackets**  
**Figure 2**

- 13.6.1 Conditions: Side-to-Side Axis, 3' hammer height
- 13.6.2 Observations: A post-blow visual inspection revealed that the top brackets had bent; refer to Figure 2. No additional obvious physical damage or discrepancies were noted.
- 13.6.3 Action: Testing was continued.

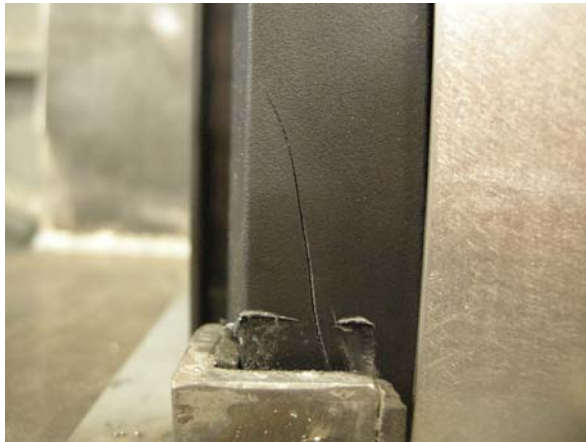
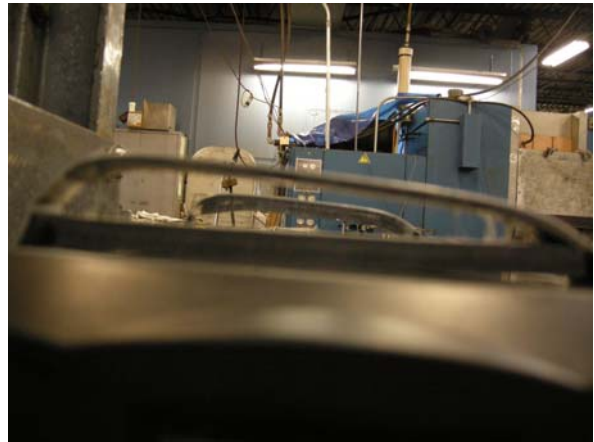
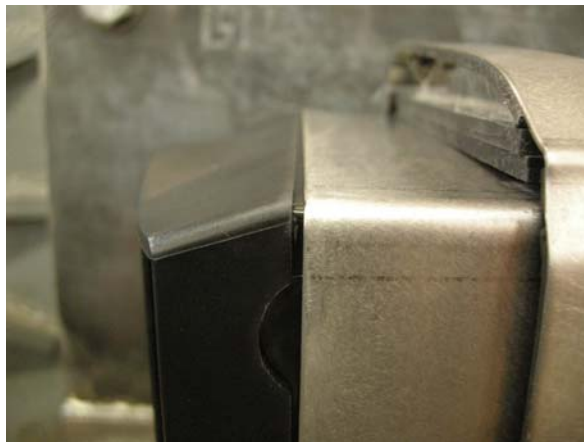
**Post-Blow #3**  
**Figure 3**

- 13.7.1 Conditions: Side-to-Side Axis, 5' hammer height
- 13.7.2 Observations: A post-blow visual inspection revealed a crack in the front plastic control panel cover. It was further noted that the top brackets had bent further, and the front plastic control panel cover was pulled away from the metal frame. Additionally, the light used to monitor the Power Supply output voltage became momentarily de-energized and then re-energized. Refer to Figure 3 for photographs. No additional obvious physical damage or discrepancies were noted.
- 13.7.3 Action: Testing was continued.

**Crack in Front Plastic Control Panel Cover**

**Bent Top Brackets**

**Front Plastic Control Panel Cover Pulled Away from Metal Frame**

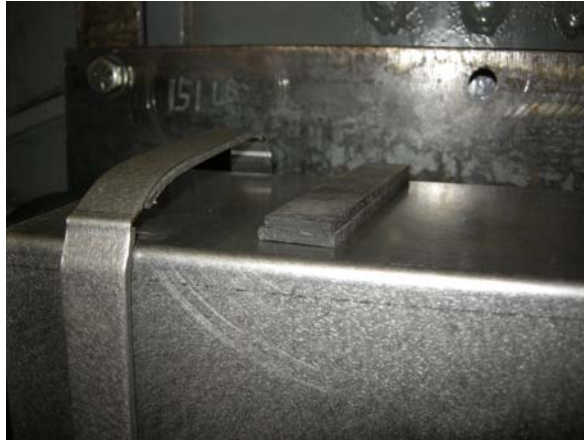
**Post-Blow #4  
Figure 4**

- 13.8.1 Conditions: Top Axis, 1' hammer height
- 13.8.2 Observations: A post-blow visual inspection revealed that the neoprene cushion that was attached to a mounting strap had become detached and remained on top of the Power Supply and Plate; refer to Figure 4. No additional obvious physical damage or discrepancies were noted.
- 13.8.3 Action: Testing was continued.

**Detached Neoprene Cushion**

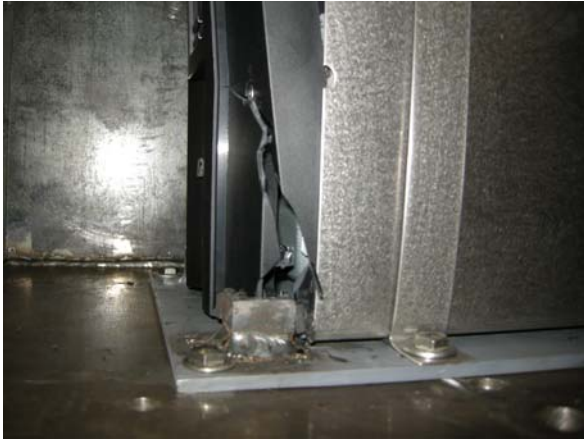
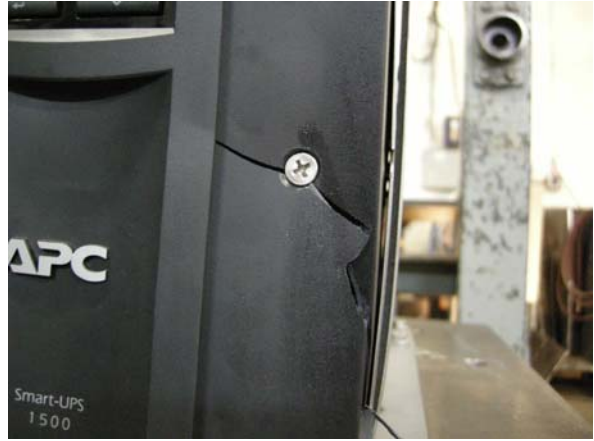
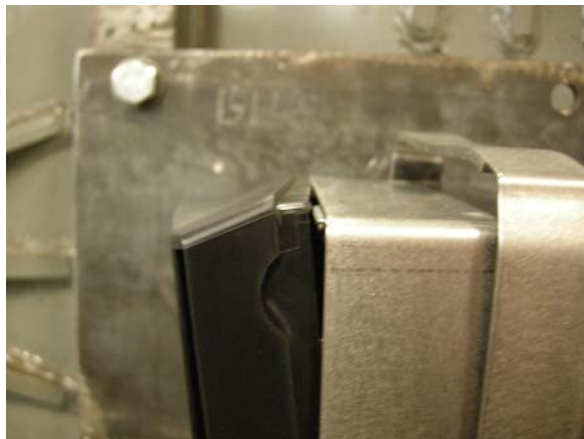
**Post-Blow #8  
Figure 5**

- 13.12.1 Conditions: Front-to-Back Axis, 3' hammer height
- 13.12.2 Observations: A post-blow visual inspection revealed that the front plastic control panel cover had become significantly damaged. The plastic on the bottom of the Power Supply and Plate also displayed damage. Refer to Figures 5 and 6 for photographs. No additional obvious physical damage or discrepancies were noted.
- 13.12.3 Action: Testing was continued.

**Damage to the Front of the Power Supply and Plate**

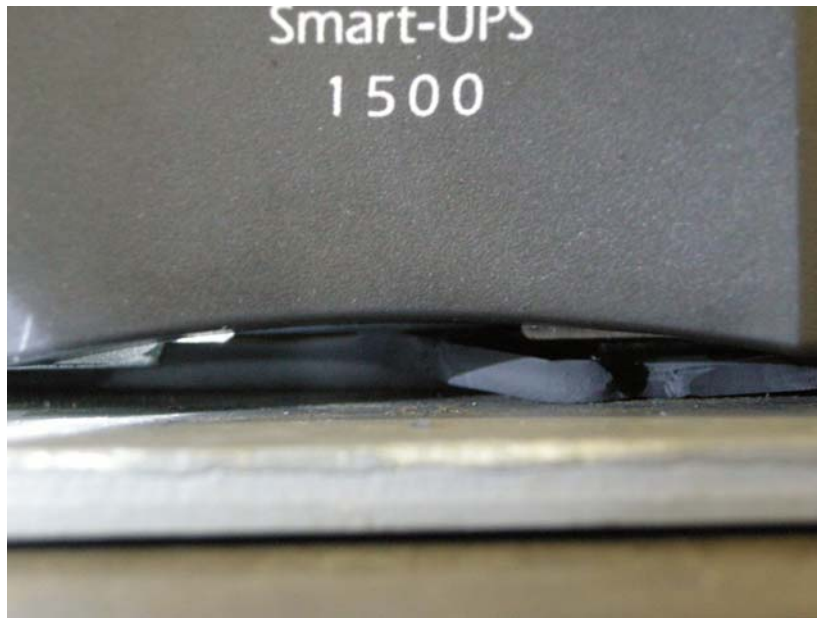
**Post-Blow #8  
Figure 6**

**Damage to the Front of the Power Supply and Plate**

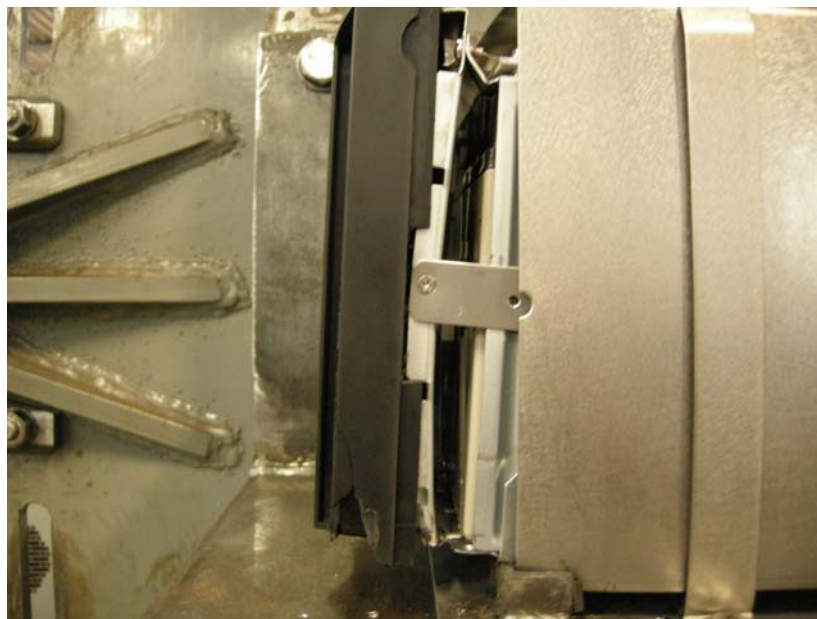
**Post-Blow #9  
Figure 7**

13.13.2 Observations: A post-blow visual inspection revealed extensive damage to the front panel of the Power Supply and Plate. In addition, a screw and plastic shards had come adrift from the front panel of the Power Supply and Plate. It was further noted that the metal mounting straps had become twisted. The Powerstar Inc. representative noted that a rivet had become detached from a metal mounting strap. Refer to Figures 7 and 8 for photographs. No additional obvious physical damage or discrepancies were noted.

**Damage to the Front Panel of the Power Supply and Plate**

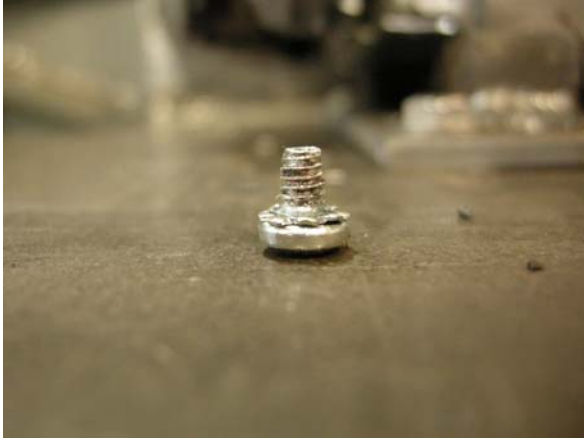
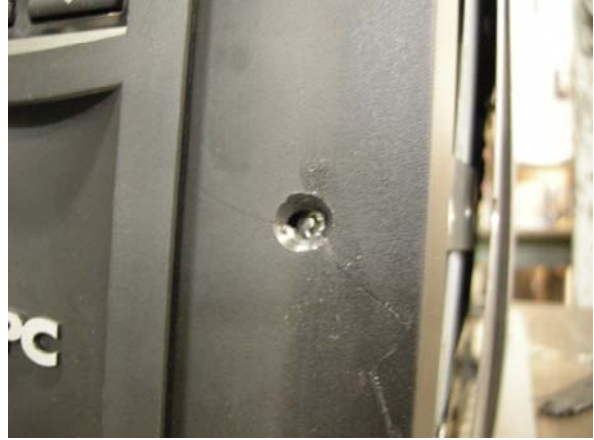
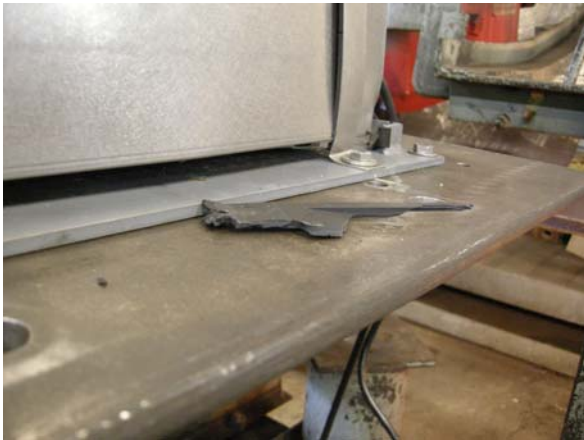
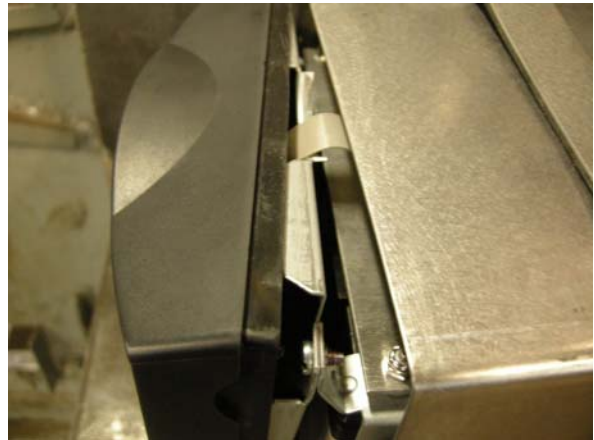
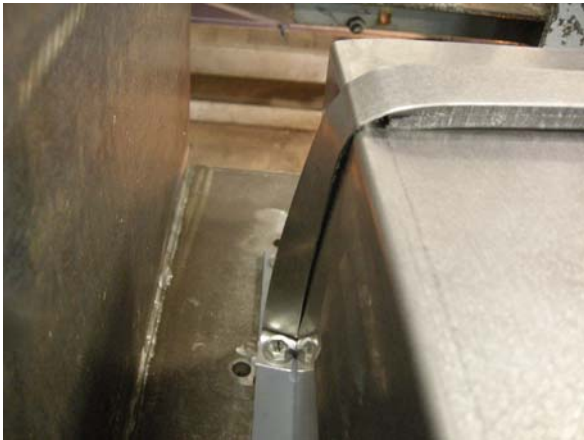
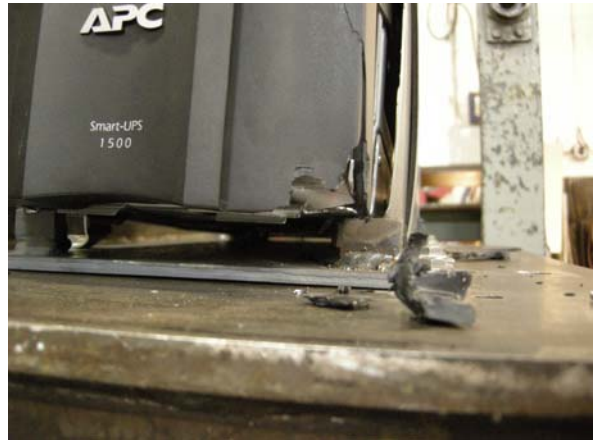
**Post-Blow #9  
Figure 8**

**Detached Screw**

**Front Panel, Source of Detached Screw**

**Detached Plastic Shard**

**Damage to the Front Panel**

**Twisted Metal Mounting Strap**
